**SAFETY RECOMMENDATION**

**Subject: accident occurred on Lasa (Bolzano, Italy) airfield to the helicopter AS350 B2, registration marks I-AIRY, on May 16<sup>th</sup>, 2011.**

**Subject: accident occurred on Palermo airport to the aircraft Airbus A319 registration marks EI-EDM, on September 24th, 2010.**

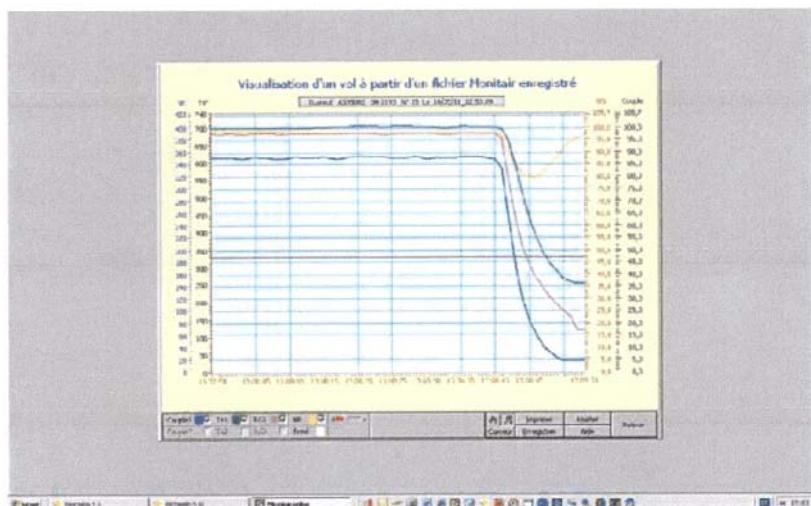
Picture 2. Data showed by "Monitair".

The "Monitair" system evidenced an in flight shut down of the engine (picture 2).

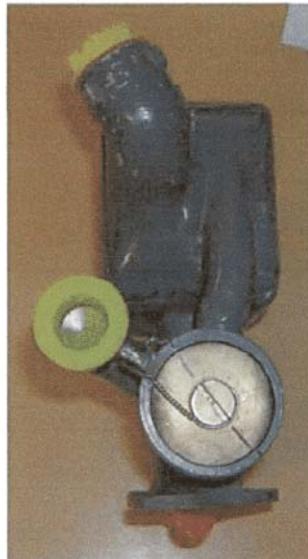
Picture 3: “oil to fuel heater”.

The test on the fuel filter revealed no discrepancy while the test on the “oil to fuel heater” showed a deep reduction between the fuel in to out pressure:

- test with fuel flow 80l/h: Inlet pressure 30 kPa; Outlet pressure 8 kPa (delta P=22 kPa);
- test with fuel flow 180 l/h: Inlet pressure 122 kPa Outlet pressure 1kPa (delta P=121 kPa).

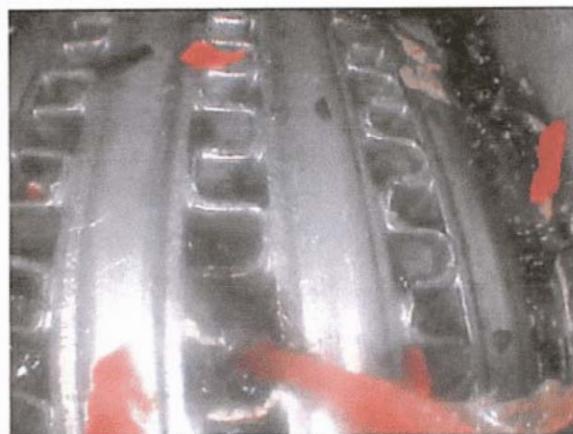
They are values not acceptable for the normal operation of the engine, so a boroscope inspection has been performed on the first part of the inlet section of the component revealing the presence of pollution and debris (picture 4). Following these new evidences, it has been decided to proceed with a test of the “oil to fuel heater” on an engine test bench equipped with fuel filter and FCU, to the engine manufacturer facilities.

Picture 4: pollution and debris found within the "oil to fuel heater" inlet duct.

The abnormal pressure drop inside the fuel heater induced cavitation phenomena on the FCU and explains the engine in flight shut down.

The lack of maintenance task on the fuel flow test or on a scheduled cleaning related to the "oil to fuel heater" appears to be linked to the conditions of the component.

- an additional inspection should be asked as soon as possible to the Operators/Owners of the helicopter type in subject now in operation (equipped with the optional Service Bulletin Nr. 28.00.09), in order to check the “oil to fuel heater” component for pollution presence and for correct fuel flow values (ANSV-16/726-11/1/A/11);
- a scheduled check should be implemented within the maintenance program of the helicopter type in subject (equipped with the optional Service Bulletin Nr. 28.00.09) in order to check the fuel flow of the “oil to fuel heater” component during its operative life and in order to perform its cleaning (ANSV-17/726-11/2/A/11).

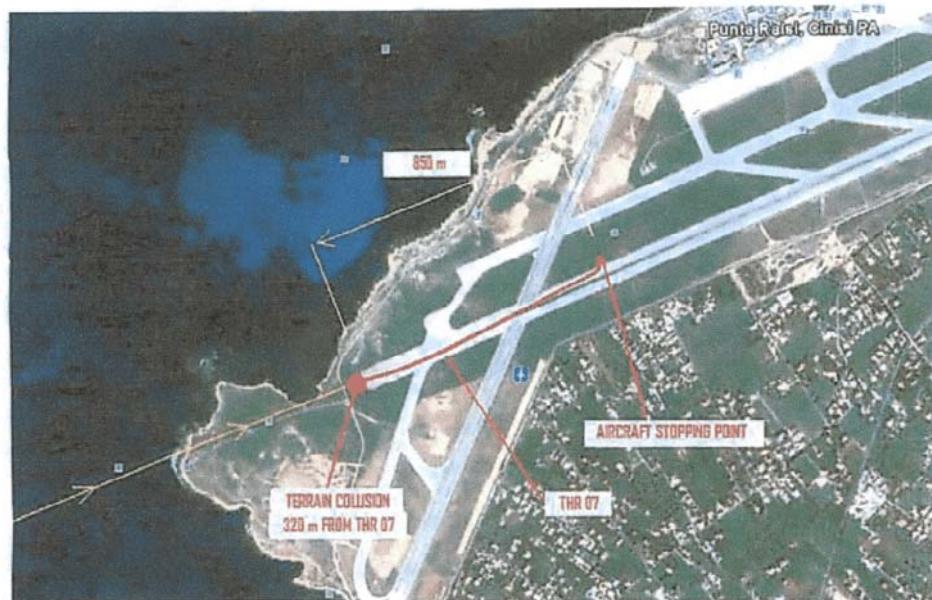
Figure 1: aircraft tracking.

At 18.08 UTC, during final approach for runway 07 with adverse meteorological conditions on Palermo airport, aircraft collided with terrain immediately before the beginning of the runway (figure 1), hit the opposite RWY localiser antenna, slid on the wet runway with main gear collapsed for about 900 meters before stopping out of the left side of the runway. Passengers evacuation was performed. Aircraft was severely damaged, very minor injuries to persons onboard.

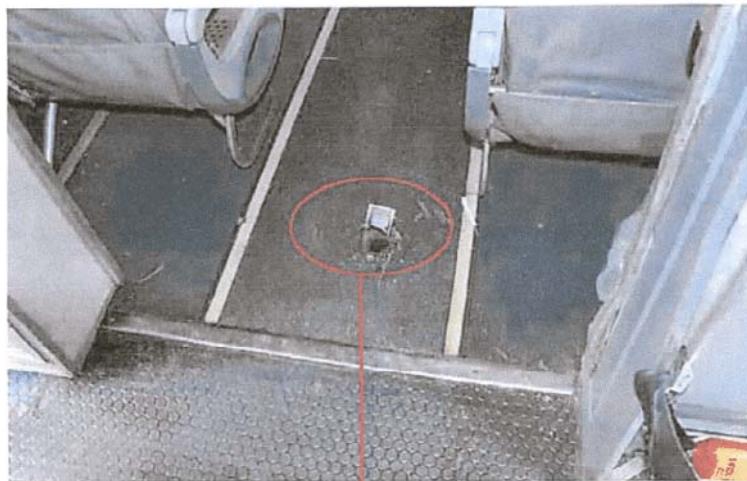
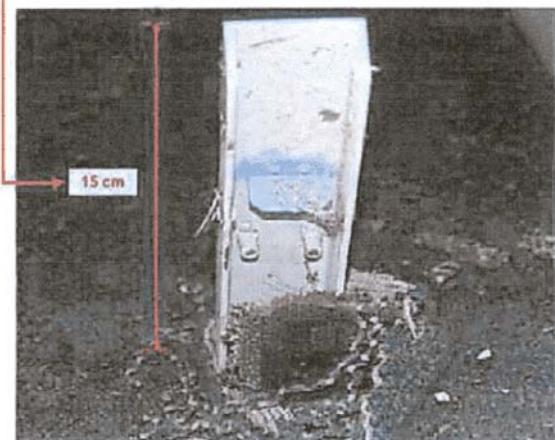
Picture 1: cross beam FR65.

During the ongoing investigation it has been determined that the frame "cross beam FR65" (picture 1 and figure 2) had penetrated the floor just in correspondence of the rear part of the escape way of the pax cabin. There is some statements who let us know that passengers fell to the ground during the cabin evacuation due to the presence of part of the FR65 coming out from the cabin floor, deeply slowing down the operation.

The pax cabin has showed a consistent grade of impact suppressor and only the FR65 damage became dangerous for survivability with specific mention to the passenger evacuation (picture 2).

The position of the only evidenced damage of the pax cabin (FR65 coming out from the baggage compartment) has hindered and deeply slowed down the evacuation to the aft emergency exits and for this reason it represents one important safety issue. Same damage due to same structural component (FR65 *cross beam*) has been experienced on the Hudson River accident occurred on January 15<sup>th</sup>, 2009 (where a deep V-shaped laceration was sustained by the flight attendant as a result of the cross beam position).

- the aim of such modification is to avoid to establish unsafe condition for passengers and for this reason the modification must be proposed as “mandatory” on all A320-family fleet now in operation (as prescribed by EASA Part 21A.3B – «a document issued or adopted by EASA ... which mandates actions to be performed on an aircraft to restore an acceptable level of safety, when evidence shows that the safety level of this aircraft may be otherwise compromised») (ANSV-18/1836-10/1/A/11).

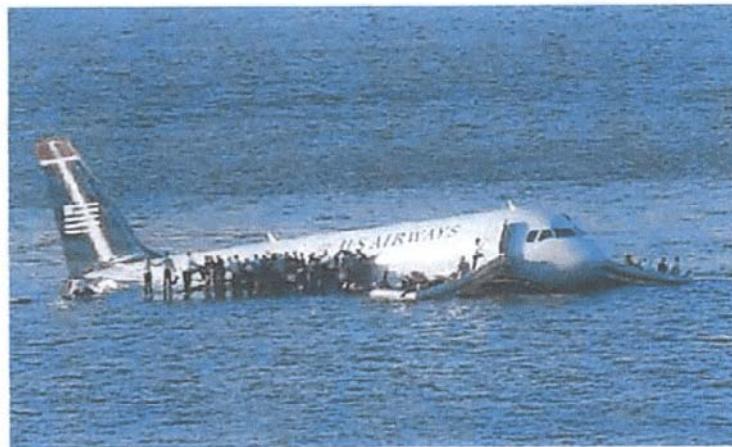
The NTSB issued on last year the Safety Recommendations A-10-92 addressed to EASA and A-10-77 addressed to FAA related to same component we are speaking about, following the investigation on the accident occurred in USA on January 15th, 2009, in which an A320-214 ditched on the Hudson River. On this accident the "cross beam FR65" come out from the pax cabin floor in the same way showed in picture 1 and the flight attendant B sustained a deep V-shaped laceration to her left shin during the accident. In that case, after ditching, people leave the aircraft from the wing and forward emergency exits due to the pitch up position of the aircraft in the river (picture 3).

Picture 3: emergency exit used on the Hudson River accident occurred on Jan 15, 2009.

For this reason the presence of the FR65 on the rear pax cabin floor did not slow down the evacuation. On the contrary, on the Palermo accident passengers used mostly the aft emergency exits because they were at ground level due to the main gear collapse (the aircraft was in a pitch up position too but on ground).
