**SAFETY RECOMMENDATION**

**Subject: accident occurred on Lasa (Bolzano, Italy) airfield to the helicopter AS350 B2, registration marks I-AIRY, on May 16<sup>th</sup>, 2011.**

**Subject: accident occurred on Palermo airport to the aircraft Airbus A319 registration marks EI-EDM, on September 24th, 2010.**

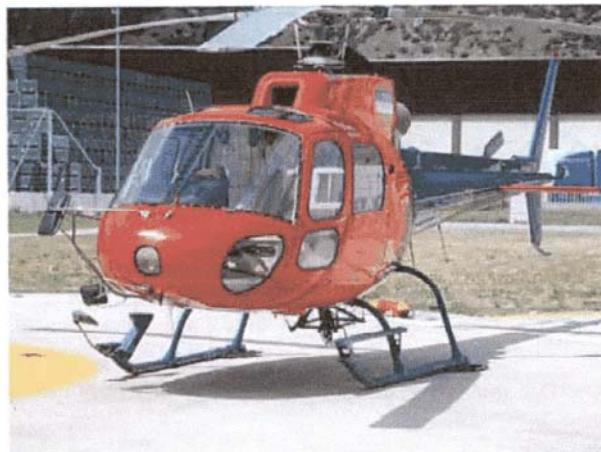
Picture 1: Eurocopter AS350B2 registration marks I-AIRY.

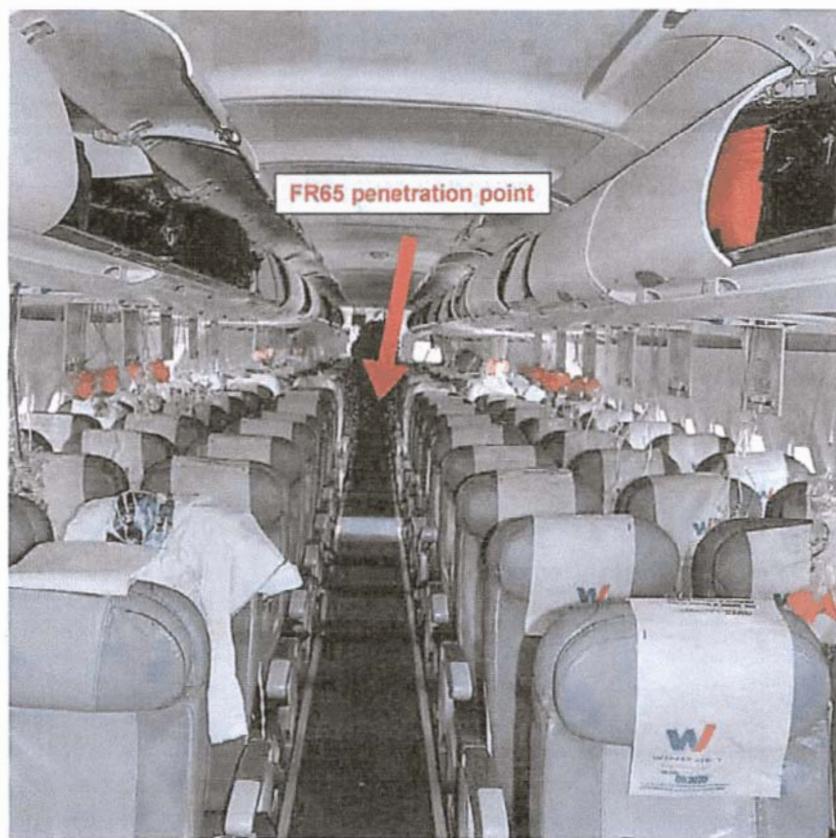
Figure 2: cross beam FR65 - Structural repair manual.

During the ongoing investigation it has been determined that the frame "cross beam FR65" (picture 1 and figure 2) had penetrated the floor just in correspondence of the rear part of the escape way of the pax cabin. There is some statements who let us know that passengers fell to the ground during the cabin evacuation due to the presence of part of the FR65 coming out from the cabin floor, deeply slowing down the operation.

The position of the only evidenced damage of the pax cabin (FR65 coming out from the baggage compartment) has hindered and deeply slowed down the evacuation to the aft emergency exits and for this reason it represents one important safety issue. Same damage due to same structural component (FR65 *cross beam*) has been experienced on the Hudson River accident occurred on January 15<sup>th</sup>, 2009 (where a deep V-shaped laceration was sustained by the flight attendant as a result of the cross beam position).
